PHOTOGRAPHIC INTERPRETATION REPORT

IMPROVEMENTS TO ROUTE 1A
NORTH VIETNAM

NPIC/R-88/69

OCTOBER 1969

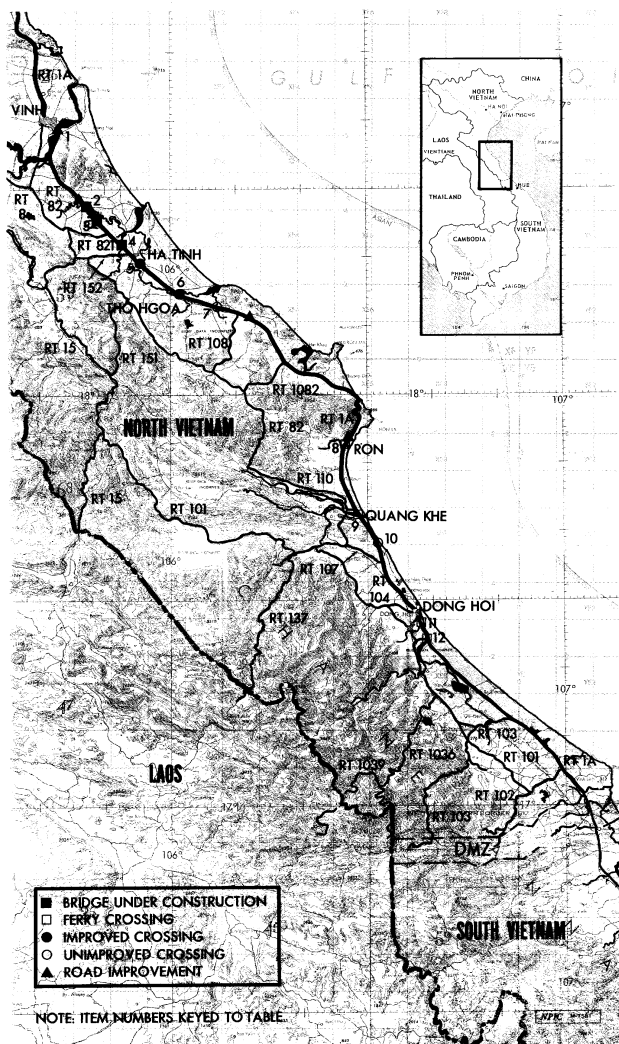
FIGURE 1. RIVER CROSSINGS, ROUTE 1A, NORTH VIETNAM

There are 107 river or stream crossings observed on Route 1A between Vinh and the Dong Hoi area. Twelve of these are considered major crossings; seven involve bridging, and five utilize highway ferries. Of the seven crossings involving bridging, three are under construction, two have been improved and are in operation, and two are unimproved (Figure 1, Table 1). The remaining 95 crossings are at smaller rivers and streams and utilize a culvert/causeway.

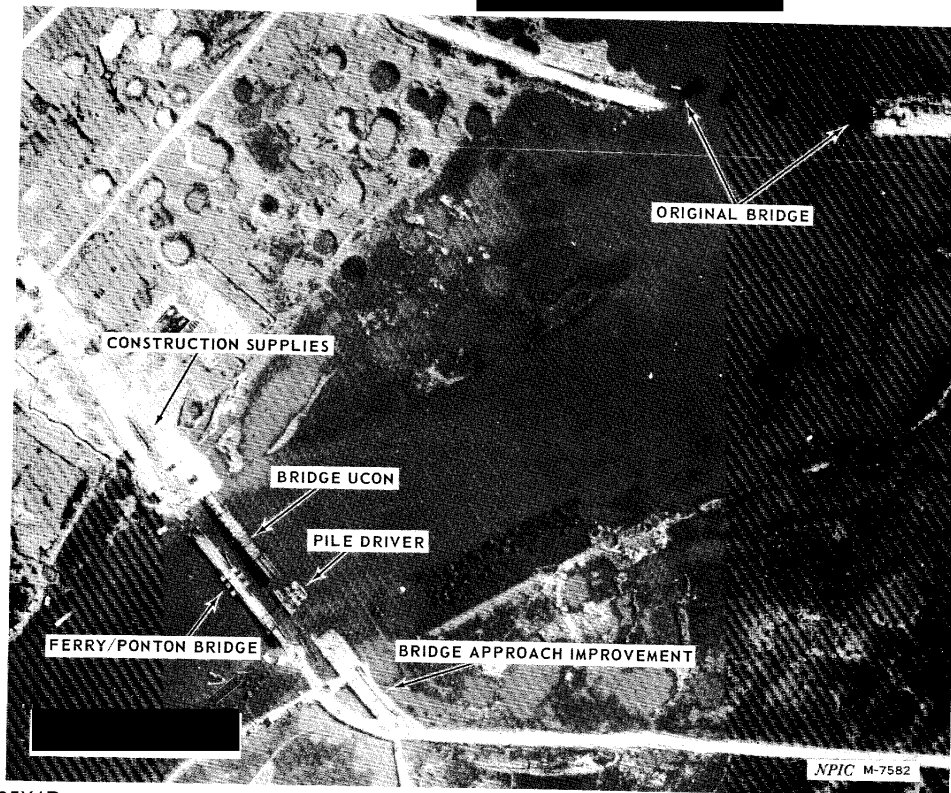
The heaviest concentration of construction activity has been observed between Vinh and Tho Hgoa, 8.5 nautical miles (nm) south of Ha Tinh. This segment of Route 1A contains six of the 12 major crossings, including the Vinh Highway Ferry, as well as two of the areas of road improvement observed. The Tho Son crossing, under construction in (Figure 2), was observed complete, except for some decking and improved approaches, in late . At Xom Gia, 2.5 nm to the south, a pile driver had begun preliminary construction work in late (Figure 3) and work has continued through . Tho Son and Xom Gia are examples of the construction techniques used for the newer bridges and also reflect the difficulties encountered with the combination ferry and ponton bridge crossing. At these crossings, traffic must drive down the river bank and through water before getting onto the bridge.

FIGURE 2. BRIDGE UNDER CONSTRUCTION, THO SON, NORTH VIETNAM

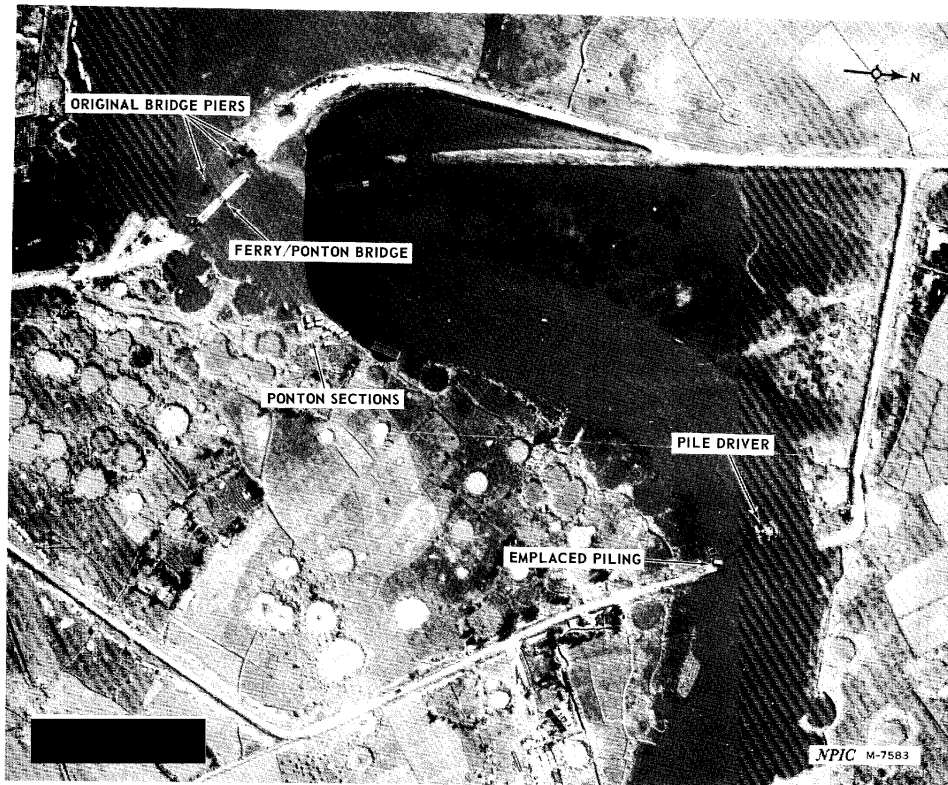
FIGURE 3. BRIDGE IMPROVEMENT, XOM GIA, NORTH VIETNAM

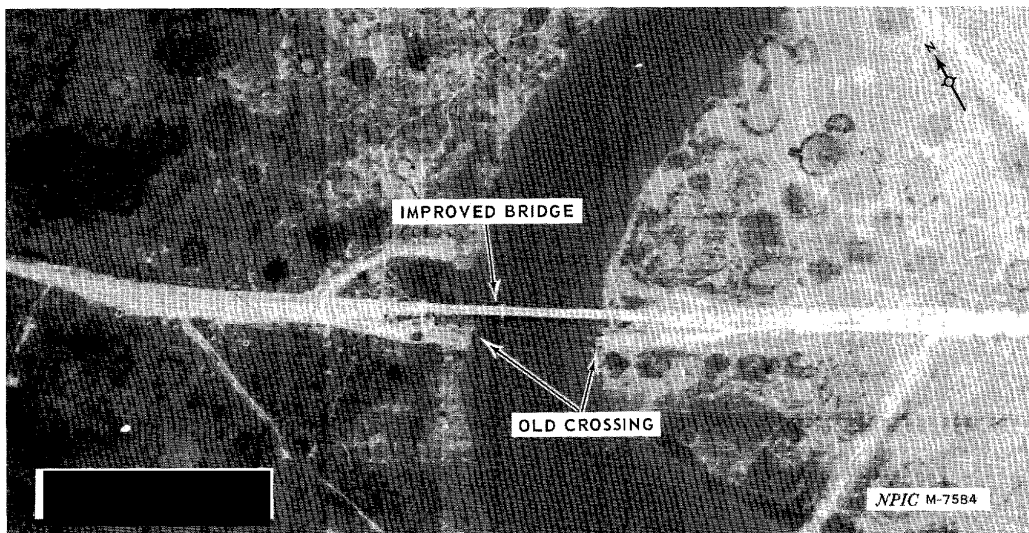
There are two crossings at Ha Tinh; one is 2 nm north of the city and the other is 1.5 nm south. The northern crossing is under construction. The southern crossing (Figure 4) and the one at Tho Ngoa farther south are the two points where the crossing has been improved and is in operation. This segment of Route 1A between Vinh and Ha Tinh is the main connecting route by means of Routes 821 and 152 with the major inland Routes 82 and 15. Traffic moving inland would probably use Route 1A to make the connection.

FIGURE 4. IMPROVED RIVER CROSSING, HA TINH, NORTH VIETNAM

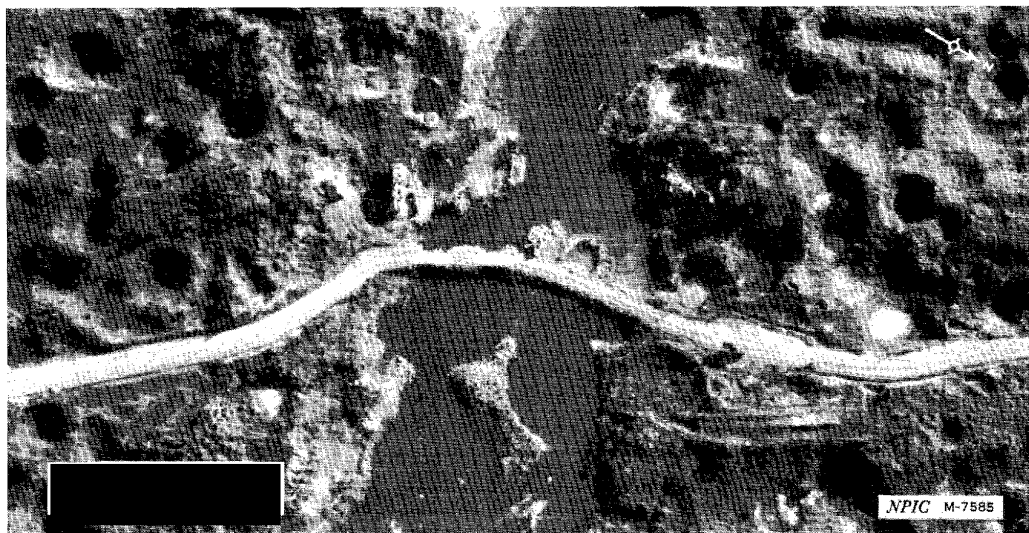
Route 1A from Quang Khe to Dong Hoi is in good condition and is in use. At Xom Phuong, 7 nm north of Dong Hoi, a typical culvert/causeway of the type utilized at most of the crossings is observed (Figure 5).

FIGURE 5. CULVERT/CAUSEWAY-TYPE CROSSING, XOM PHOUNG, NORTH VIETNAM

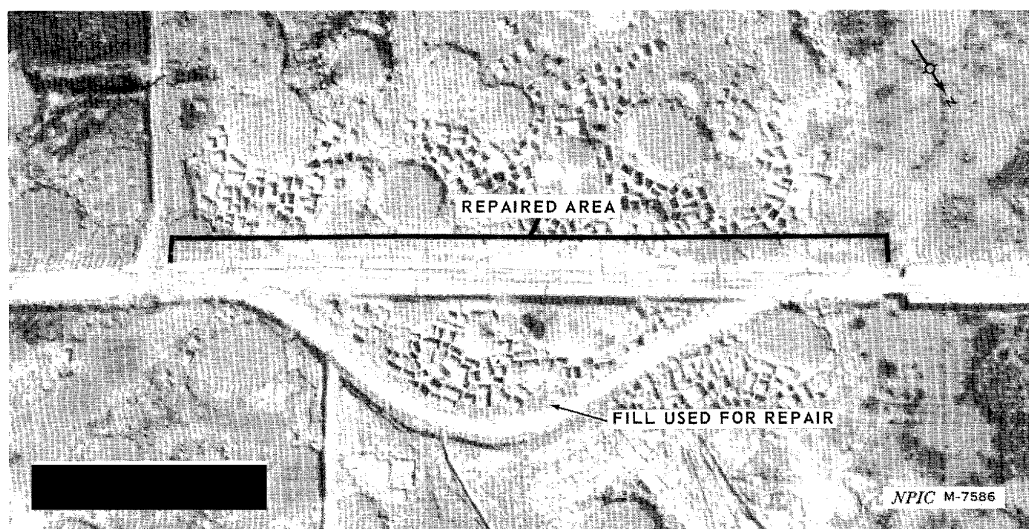
In addition to the improved bridge crossings on Route 1A, several areas of road improvement are also observed in areas of heavy bomb interdiction and in washed-out areas. The repairs consist of fill from the surrounding area being moved onto the right of way to form a good base and, in some cases, of wet earth being transported from adjacent fields (Figure 6). This forms a smooth hard surface when dry. These improvements indicate that the North Vietnamese consider Route 1A to be an important part of their over-all lines of communication.

FIGURE 6. ROAD IMPROVEMENT, ROUTE 1A, NORTH VIETNAM
